Structural Solutions Solved for Impressive Dallas Hospital

By Thomas Taylor, PE

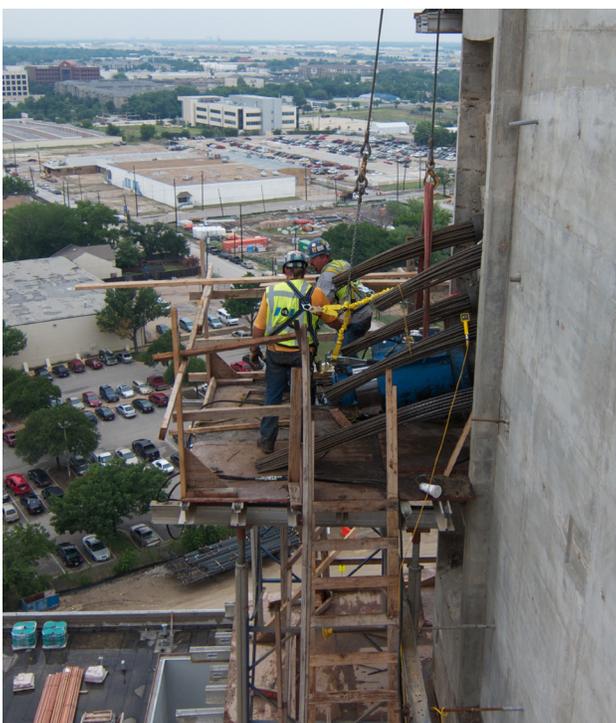
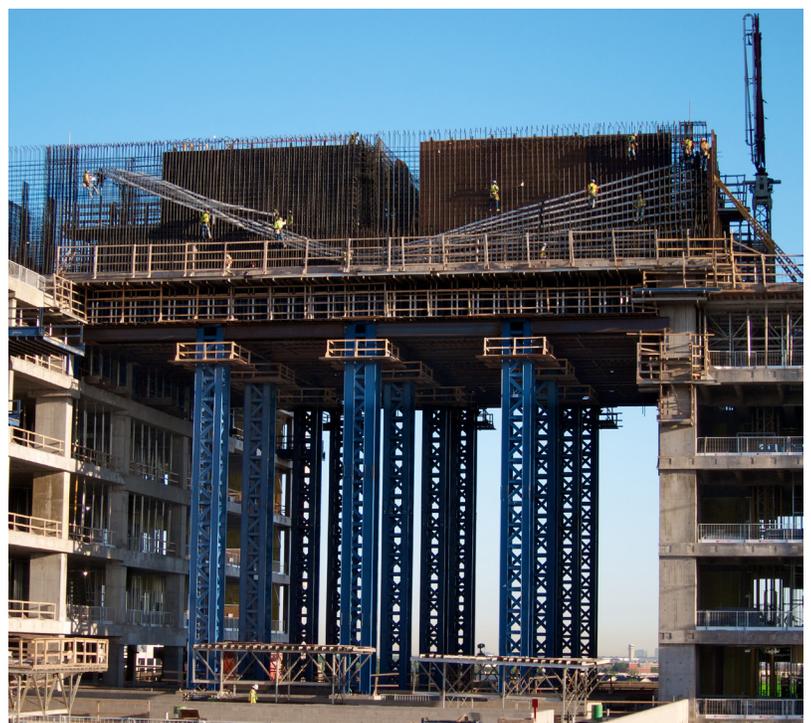
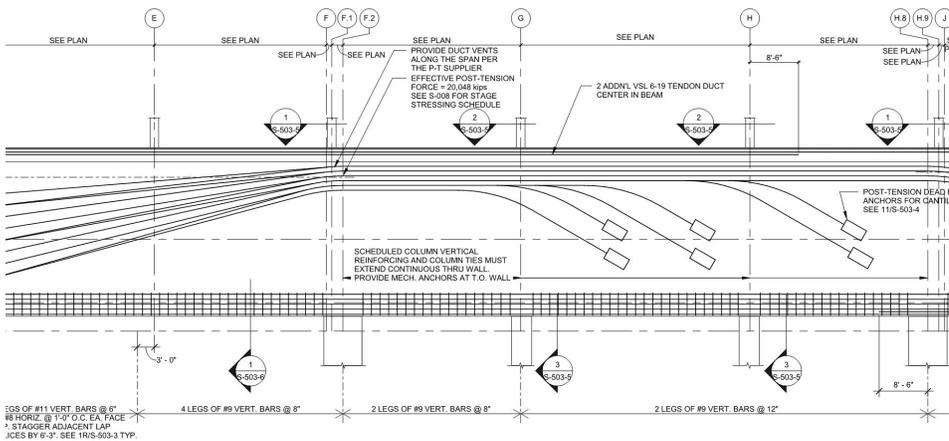
Due to the close spacing of the steel stirrups, the structural engineers created openings in the reinforcing steel to allow the concrete hoses to be inserted through the steel to the bottom of the form. This was an important detail to improve constructability.

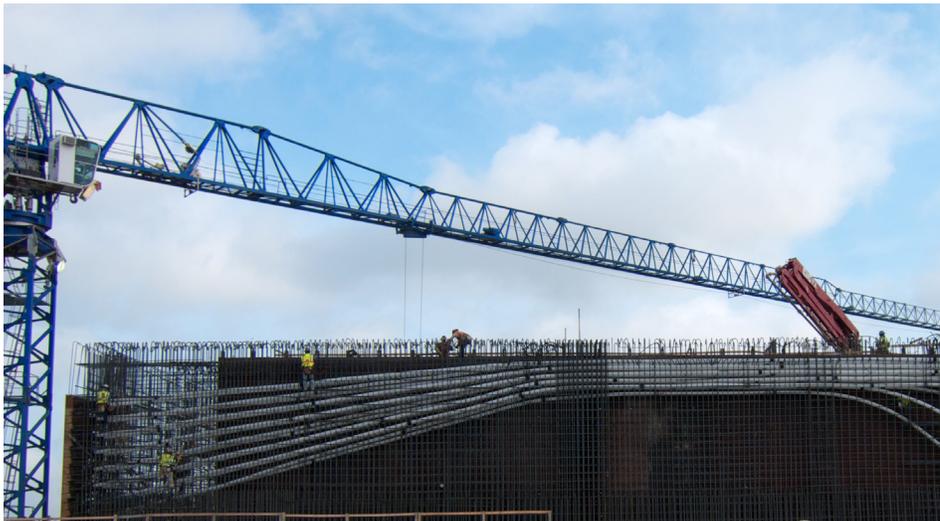
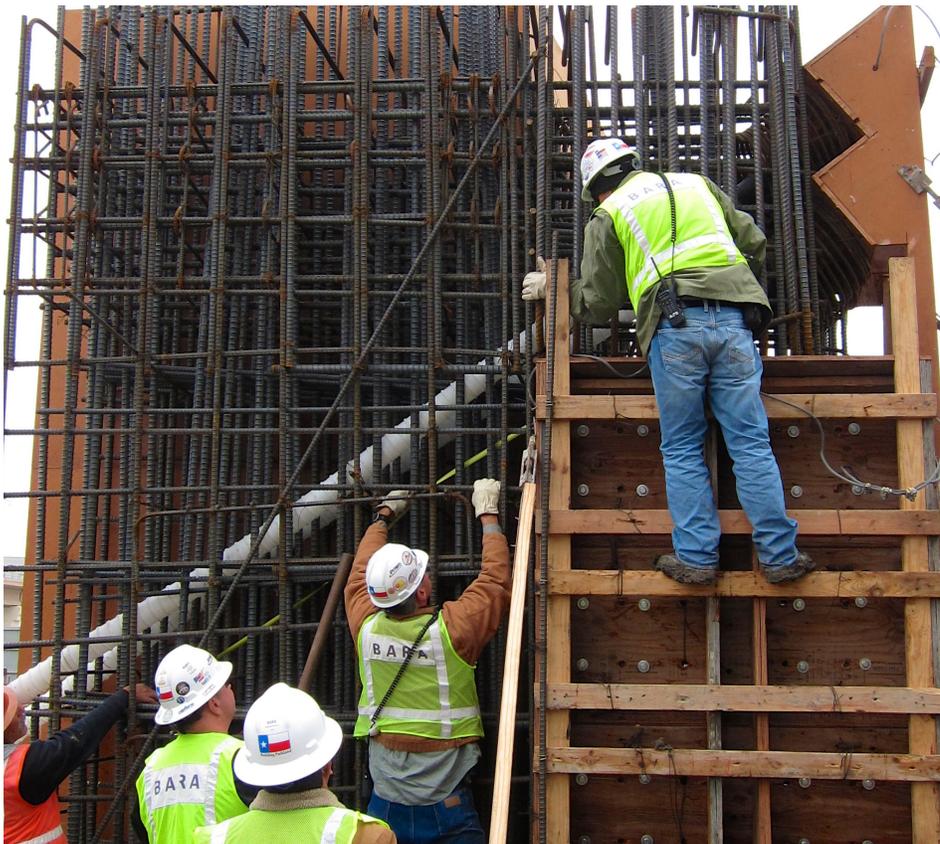
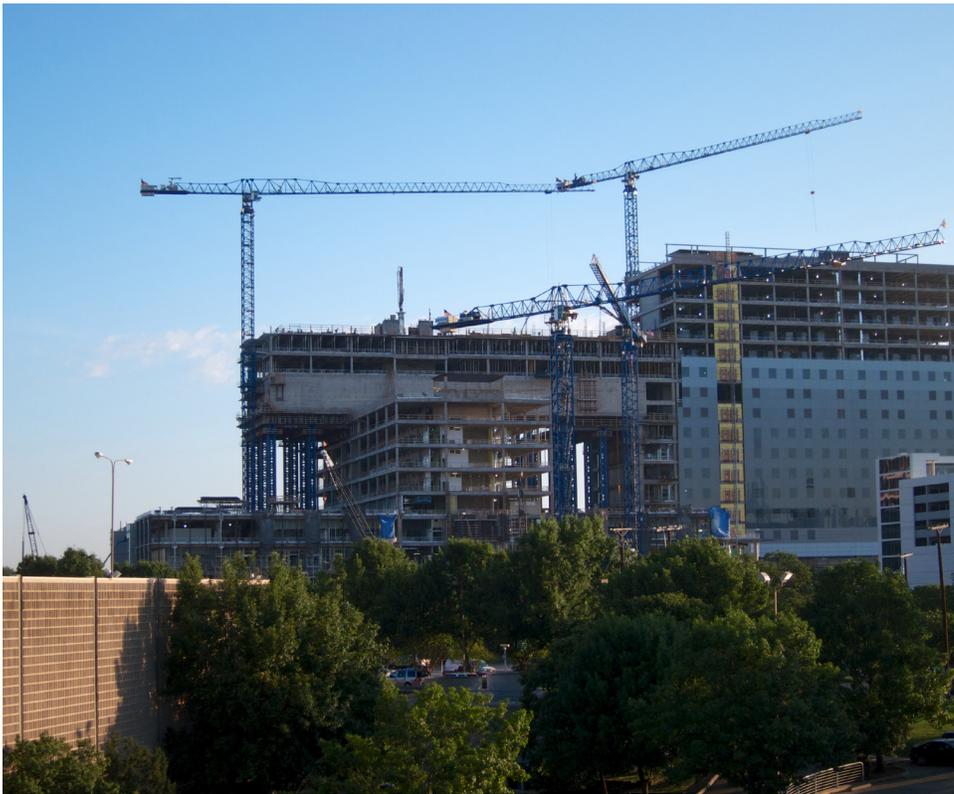
The post-tensioning solution included stage stressing and grouting of the tendons. The tendons were installed and stressed as each floor was poured. The appropriate amount of stress was applied to support the weight of the addition of each floor, and after stressing, the tendons were grouted. Each floor was cast level and then the contractor would cast the next floor. When construction of each area began, the weight of the transfer girder on the 10th floor required the post-tensioning

of six conduits. There are 31 tendons in each conduit. After pouring the transfer girder and tensioning the six conduits, the next floor was poured. This step-and-repeat process continued until the roof was poured and completed. A stressing jack was used to stress the tendons in the conduit at the end of the transfer girder.
