Open Parking Structures

Recommendations for the Design, Construction and
Maintenance to Improve Life Cycle Cost and Quality

This report discusses the advantages, disadvantages, and key specification items of each of six different structural systems. Each system has its own set of problems which must be addressed and effectively resolved on each particular project to ensure successful performance. This report includes an analysis of these problems and proposed solutions for them, as well as recommended construction details for each system.

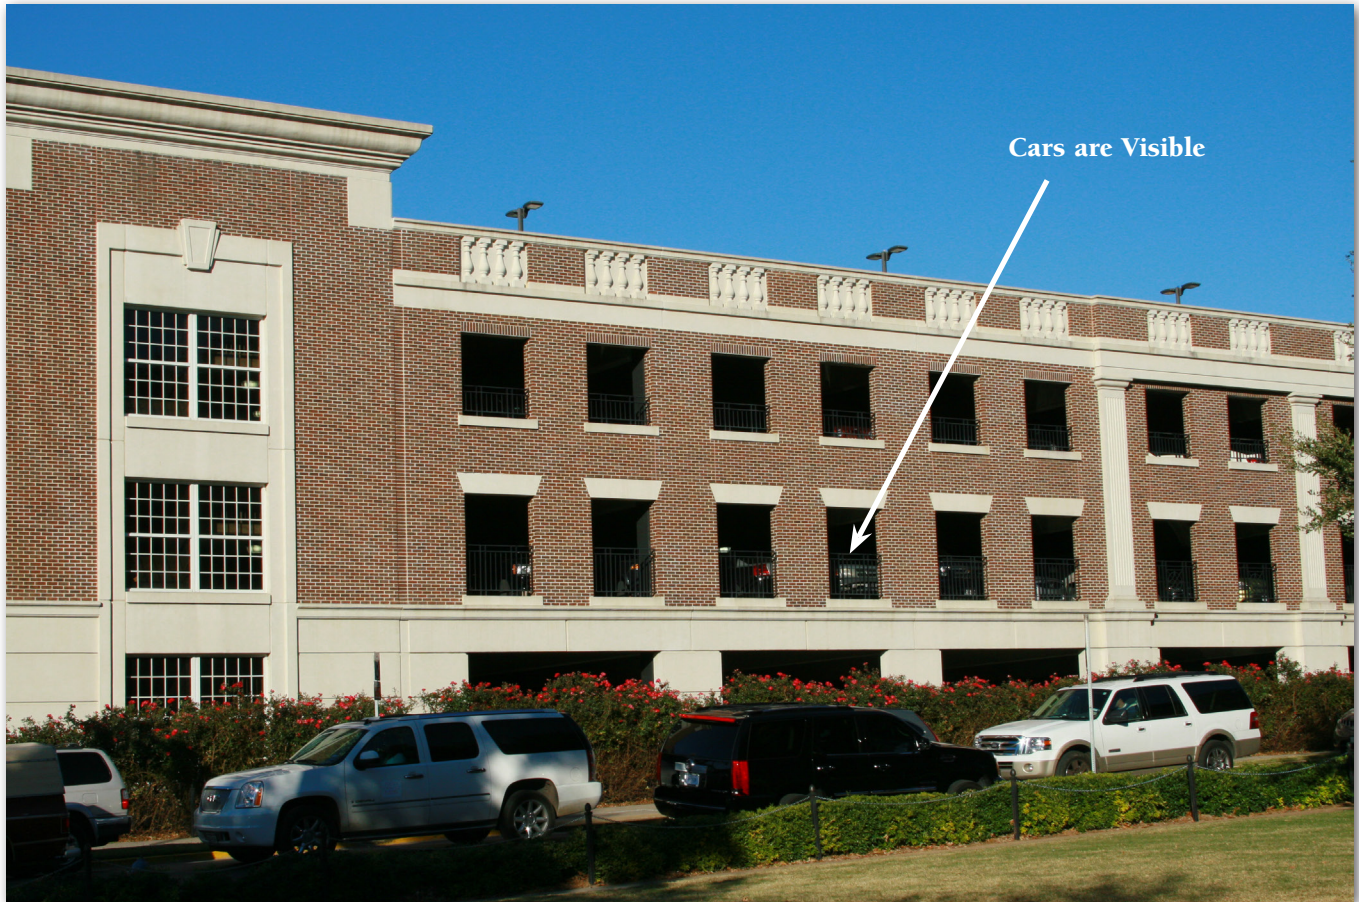
**SOUTHERN METHODIST UNIVERSITY
HILLCREST GARAGE**

TRADITIONAL DOWNTURN SPANDREL BEAM

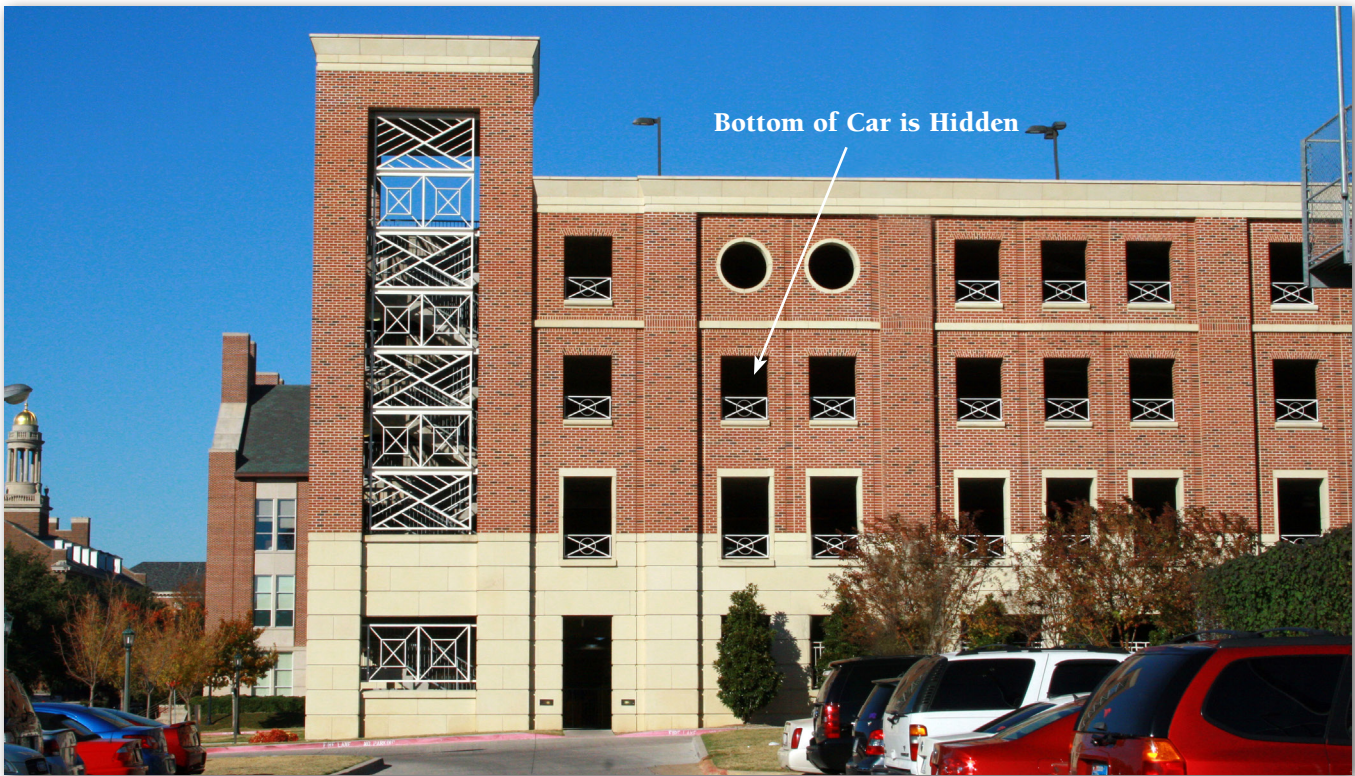
**SOUTHERN METHODIST UNIVERSITY
BINKLEY GARAGE**

DATUM UPTURN SPANDREL BEAM CONCEPT

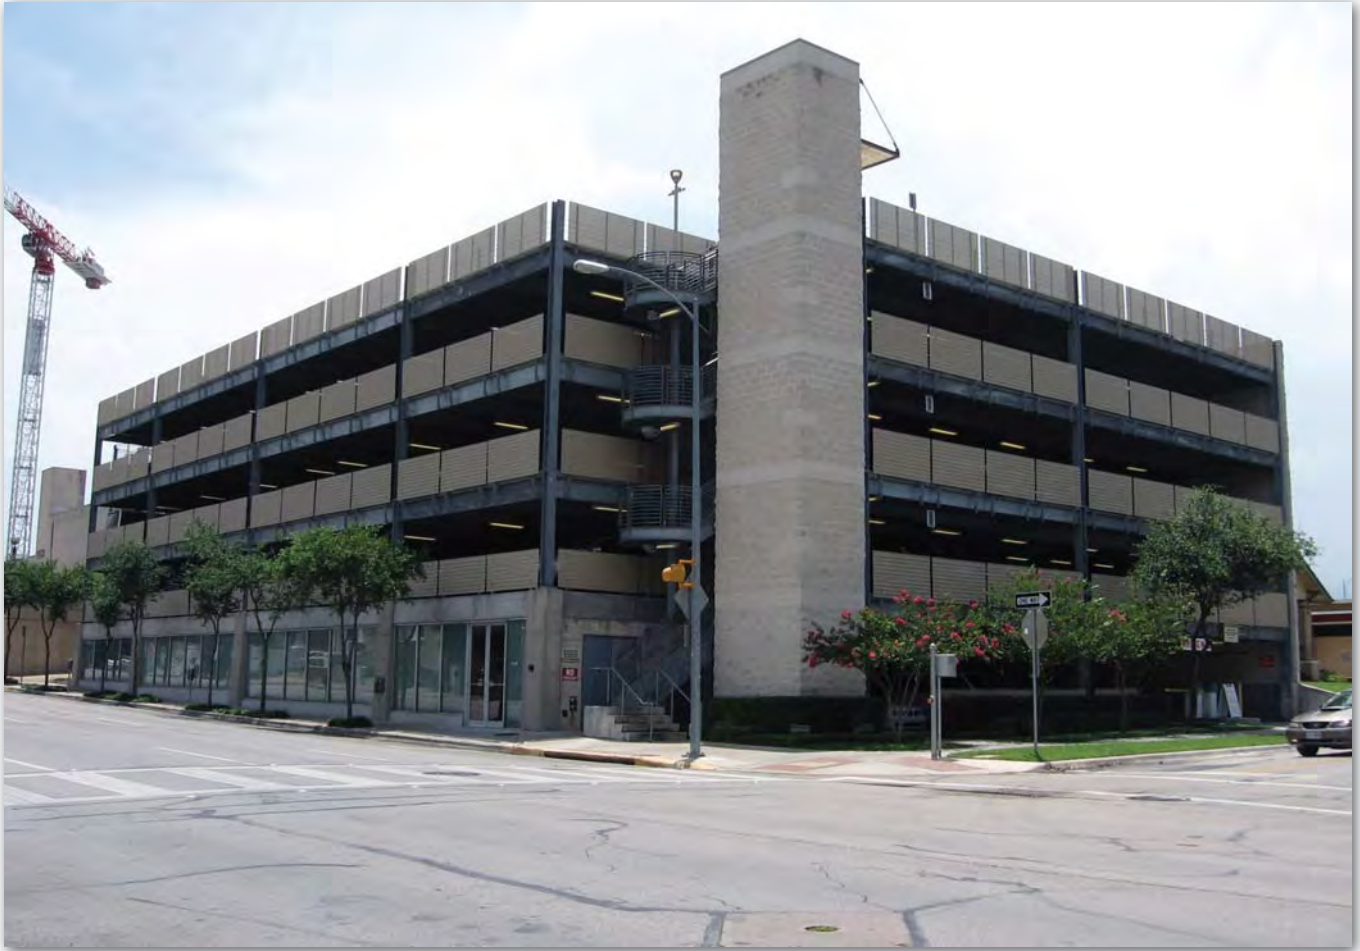
TEXAS TRIAL LAWYER'S GARAGE

STRUCTURAL STEEL SYSTEM

Structural steel columns and beams supporting a cast-in-place concrete slab on composite metal deck.
