Open Parking Structures

Recommendations for the Design, Construction and
Maintenance to Improve Life Cycle Cost and Quality

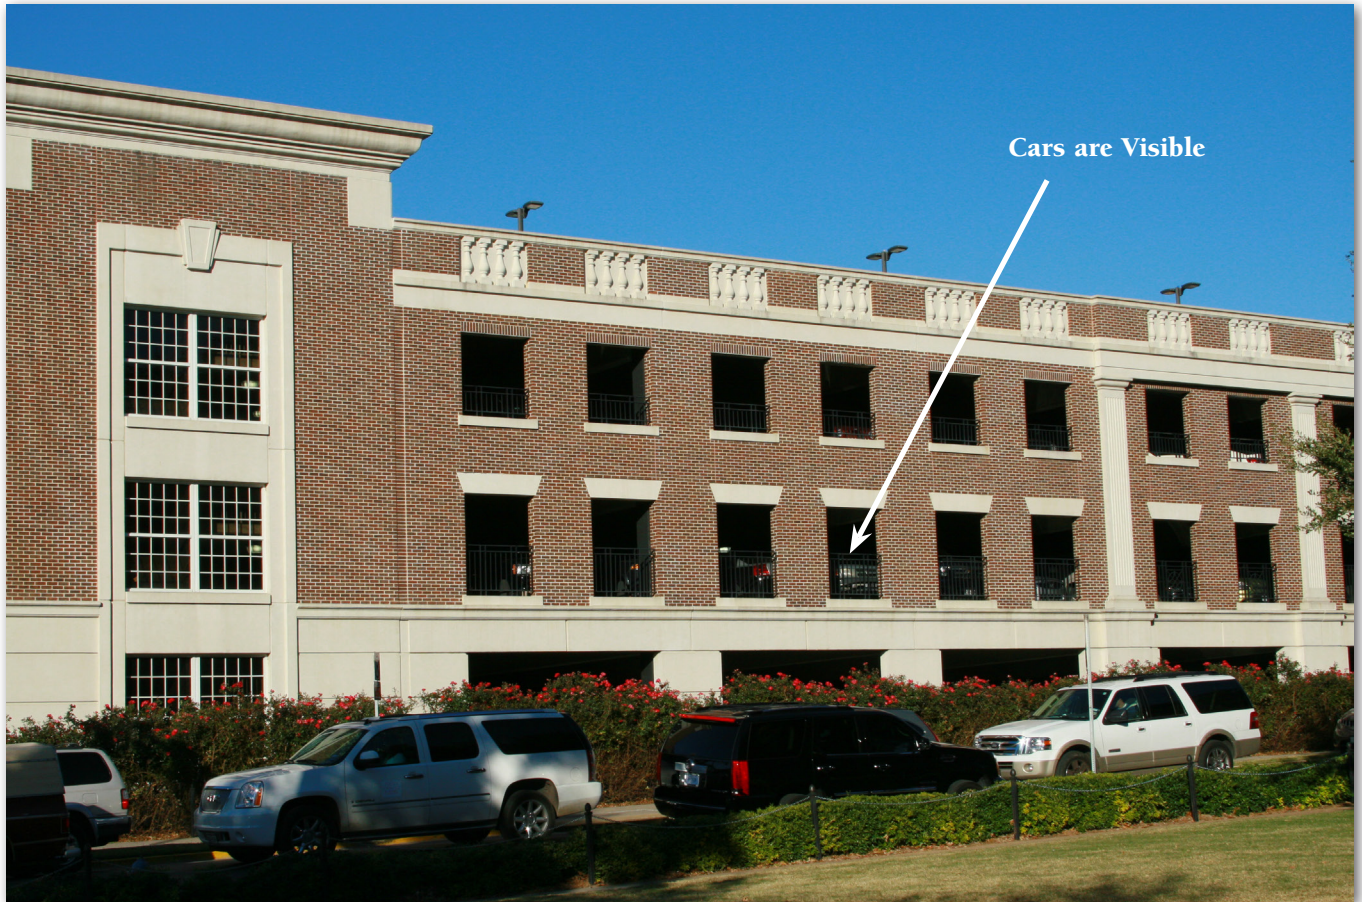
TRADITIONAL DOWNTURN SPANDREL BEAM

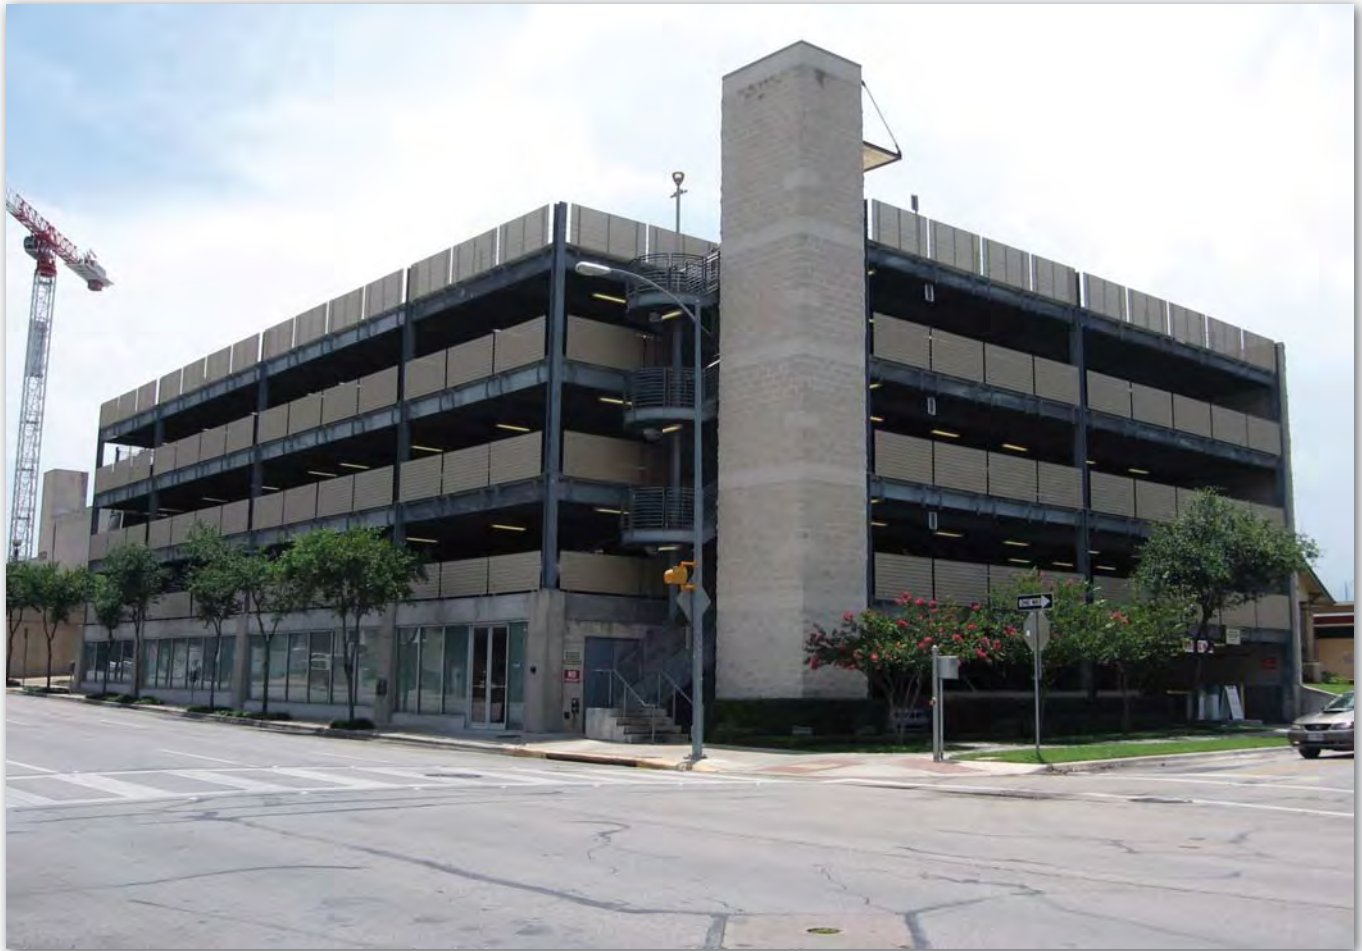
STRUCTURAL STEEL SYSTEM

Structural steel columns and beams supporting a cast-in-place concrete slab on composite metal deck.
