Open Parking Structures

Recommendations for the Design, Construction and
Maintenance to Improve Life Cycle Cost and Quality

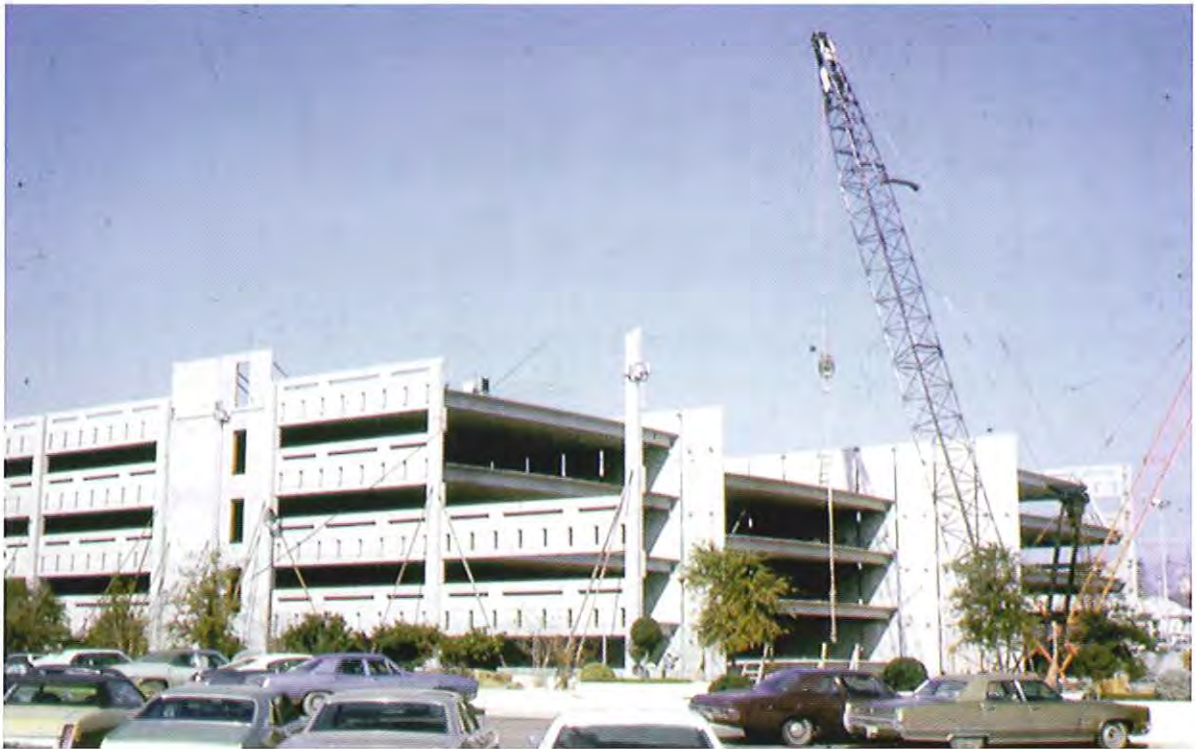
Parking Structure
Baylor Medical Center
Dallas, Texas

A new concept for constructing precast concrete parking structures was conceived for this project. Precast concrete walls ("stack walls") were used for the first time, incorporating haunches to support the sloping ramp floor on one side and the horizontal floor on the opposite side. After this project, many parking structures were designed using this notion, with either solid walls or with punched openings commonly called "lite walls."

The \$5.25 per square foot initial cost for the completed structure was impressive, even in 1974. Even more impressive is the low maintenance required over the years and the good condition of the structure thirty-five years later.

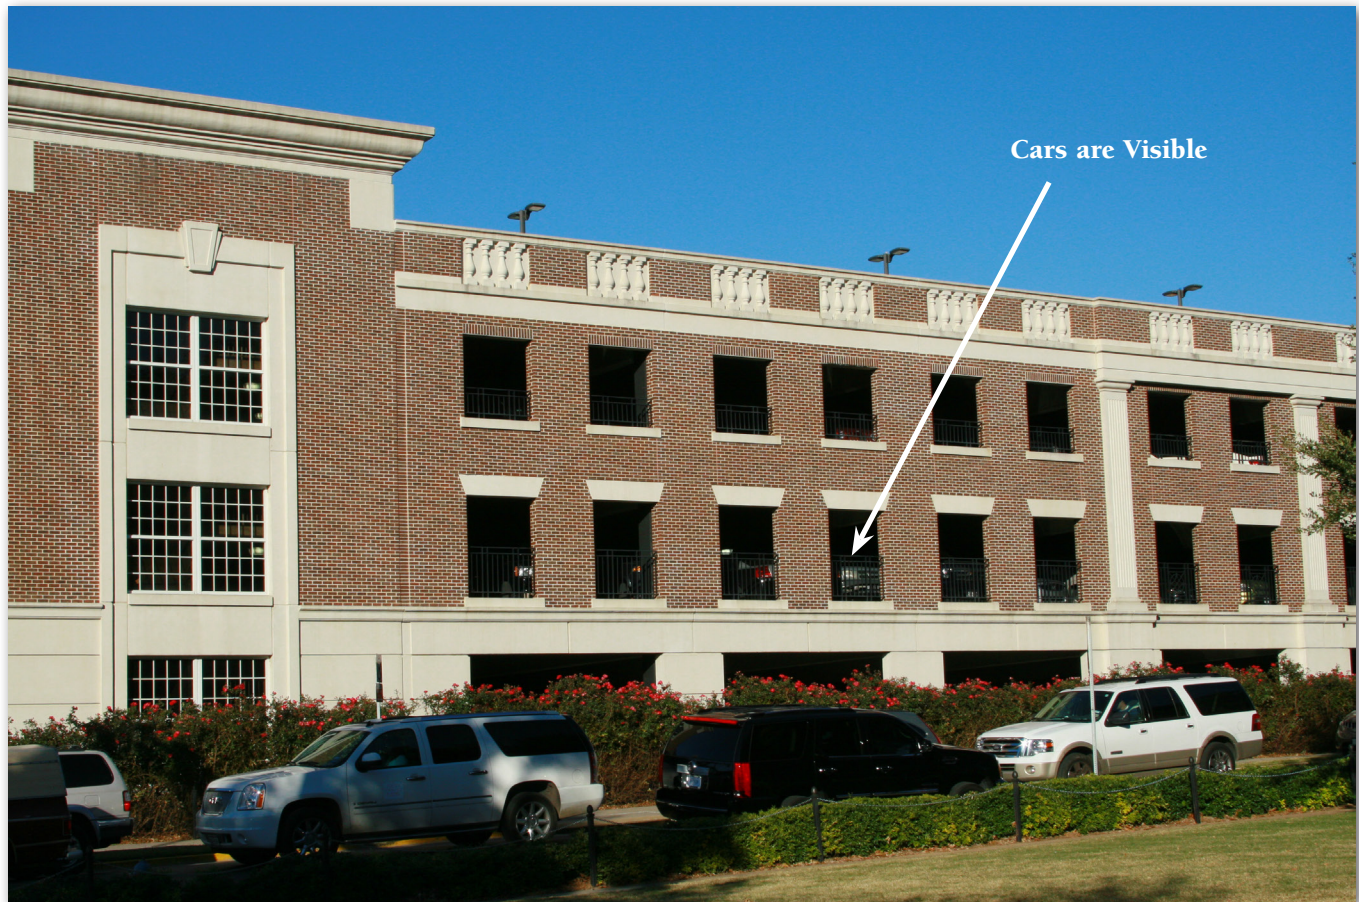
TRADITIONAL DOWNTURN SPANDREL BEAM

**SOUTHERN METHODIST UNIVERSITY
HILLCREST GARAGE**

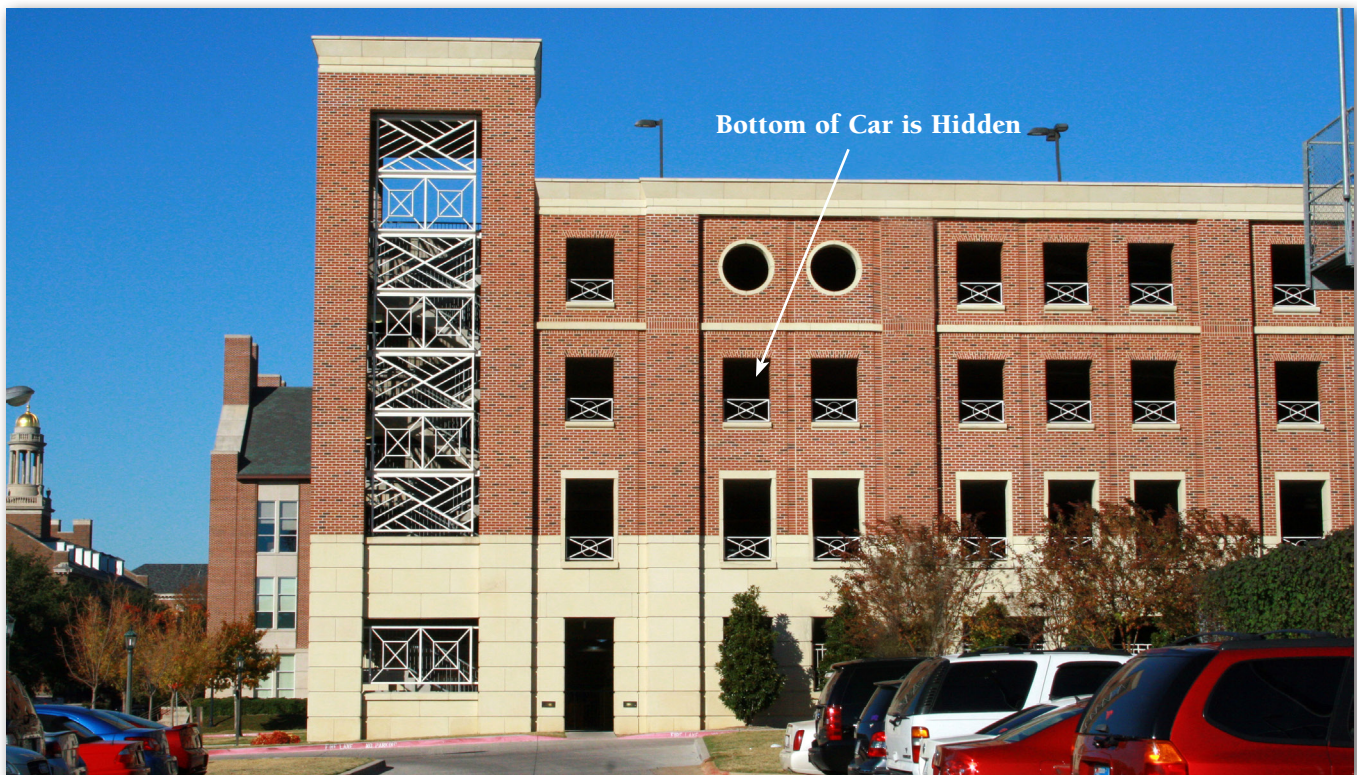
DATUM UPTURN SPANDREL BEAM CONCEPT

**SOUTHERN METHODIST UNIVERSITY
BINKLEY GARAGE**

To increase the natural lighting in the structure upturn perimeter beams were designed to allow natural light in and also hide the cars from view when walking through the campus. This increase in natural light aids in user comfort and security.

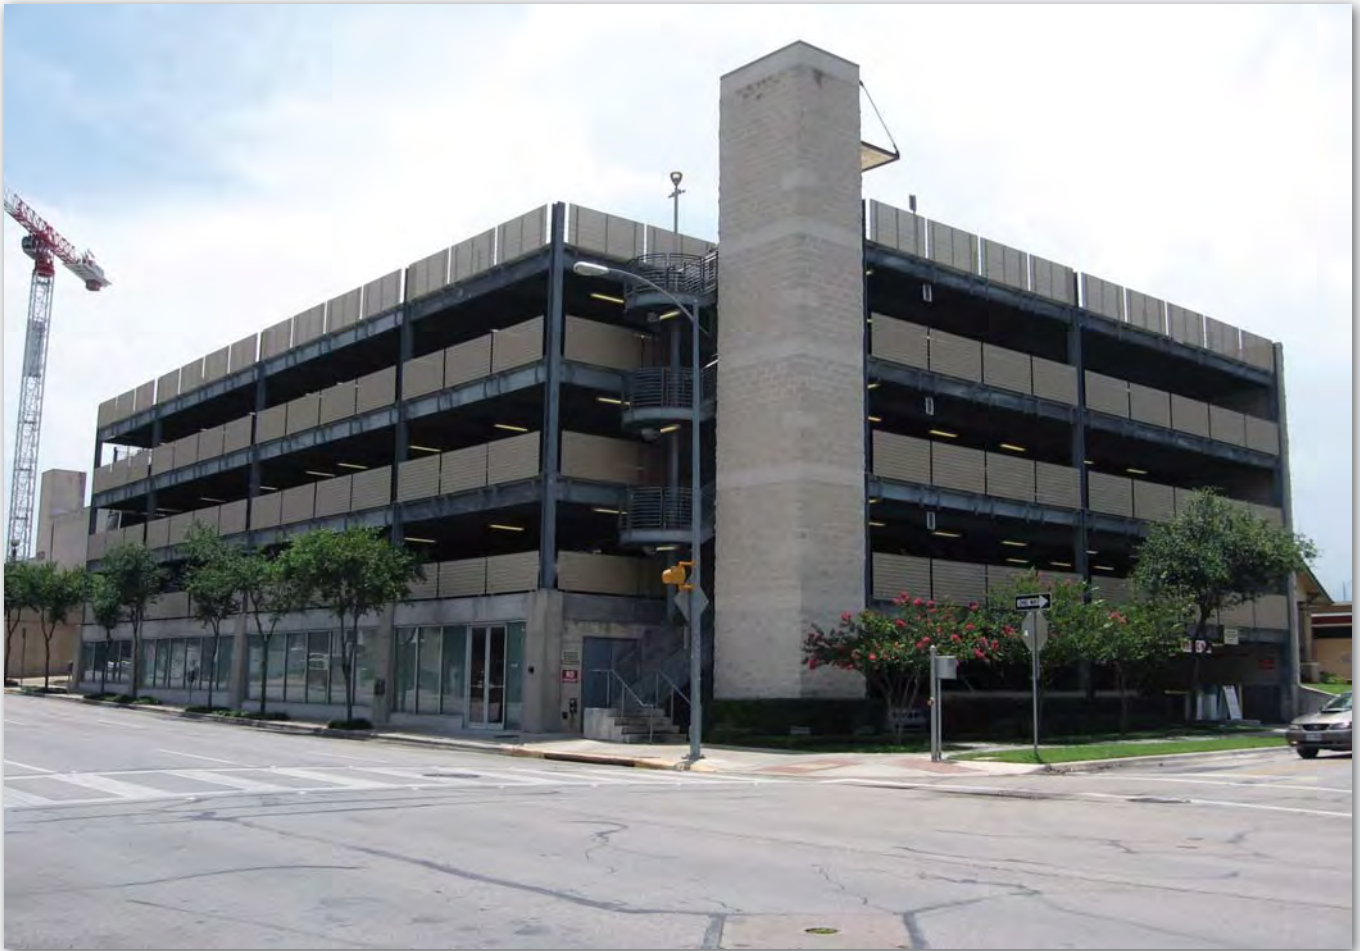
STRUCTURAL STEEL SYSTEM

Structural steel columns and beams supporting a cast-in-place concrete slab on composite metal deck.
